# Manhole Inspection Summary

Manhole # S41G\_\_024MH

Insp Date: **11/24/08 2:22 PM**

**Location** Address: **side 139 s exeter st**

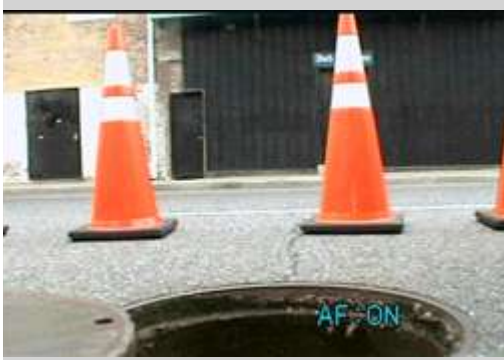
Location View

Type: **Sanitary** Condition: **Worn** Cover Material: **Cast Iron**

worn cover

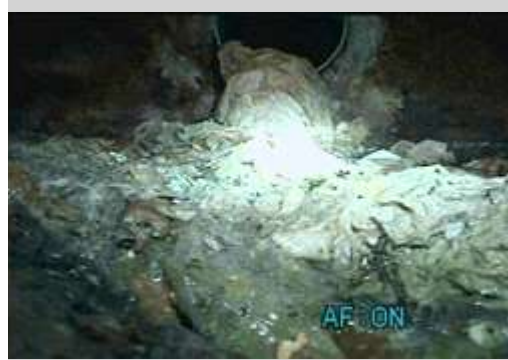
Defect 3

Condition: ☐ Sound ☐ Cracked ☐ Root Intrusion ☐ Deteriorated ☐ Leaks ☒ **Debris**

channel debris

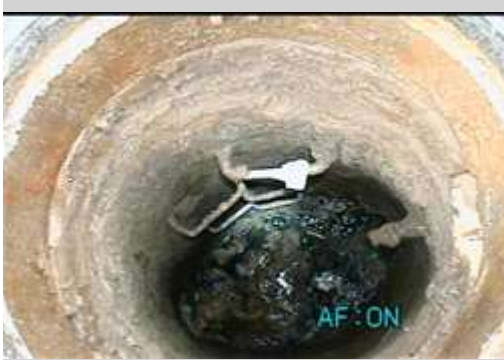
Defect 1

**Steps** Count: **5** Missing: **0** ☒ **Corroded**

**Surcharge** ☒ **Evidence Of Surcharge** Depth: **5** (ft.) ☐ Active Surcharge Present

steps corroded, surcharge evidence

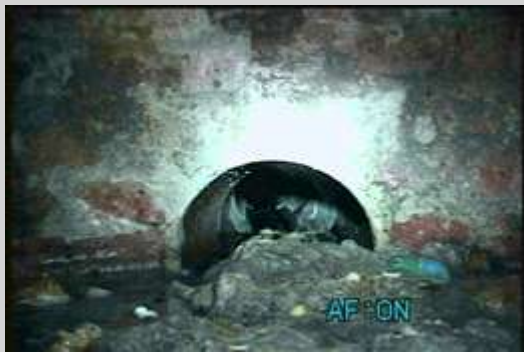
12 O'Clock Outflow

8 in. Circular Gravity Sewer  
Pipe Out @ 12 O'Clock

Pipe Material: **Clay** ☐ Pipe Lined

Invert Depth: **9.33** (ft.) Flow Characteristics: **Slow**

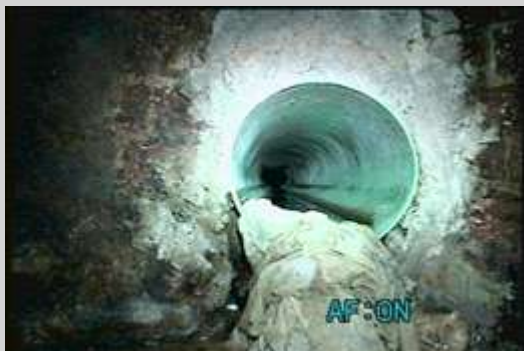
6 O'Clock Inflow

8 in. Circular Gravity Sewer  
Pipe In @ 6 O'Clock

Pipe Material: **PVC** ☐ Pipe Lined

Invert Depth: **9.16** (ft.) Flow Characteristics: **Slow**
